**Flood Control Project Maintenance  
Levee Inspections**

## Maintenance Issue Types Only, Levee Inspection Report By Mile - Spring 2018

### Marysville Levee Commission

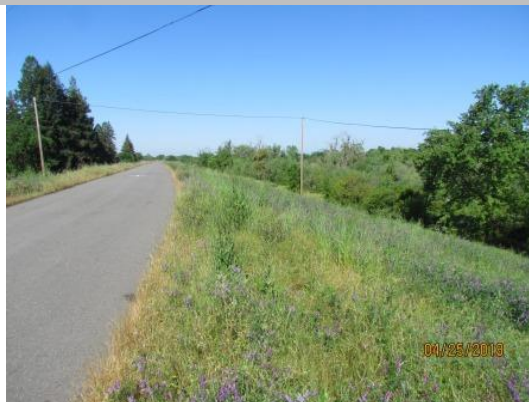
Photo 1 of 1 : SP\_2018\_NA0004\_104\_11\_20180427\_00020.jpg

LM Start	0.00	Rating **	M	Issue No.	11
LM End	3.15	Issue Type +	Ma	Location *	WS
Category	Earthen Levee			GPS Latitude/Longitude	
				Start	End
Item	Vegetation			39.149571 °	39.164076 °
				-121.601101 °	-121.560876 °
DWR ID	DWR_NA0004_01_s _ 2018_11				
Comment Code					
V1 : Control annual grass and weeds on the levee slopes and easements.					
Inspector Comment					
Annual vegetation needs to be maintained, Spring 2018.

View looking downstream waterside of the annual vegetation that needs to be maintained, Spring 2018.

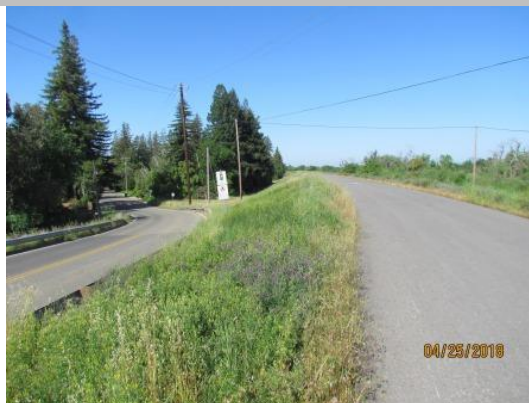
Photo 1 of 1 : SP\_2018\_NA0004\_104\_9\_20180427\_00021.jpg

LM Start	0.00	Rating **	M	Issue No.	9
LM End	3.15	Issue Type +	Ma	Location *	LS
Category	Earthen Levee			GPS Latitude/Longitude	
				Start	End
Item	Vegetation			39.149571 °	39.164075 °
				-121.601101 °	-121.560876 °
DWR ID	DWR_NA0004_01_s_2018_9				
Comment Code					
V1 : Control annual grass and weeds on the levee slopes and easements.					
Inspector Comment					
Annual vegetation needs to be maintained, Spring 2018.

View looking downstream landside of the annual vegetation that needs to be maintained, Spring 2018.

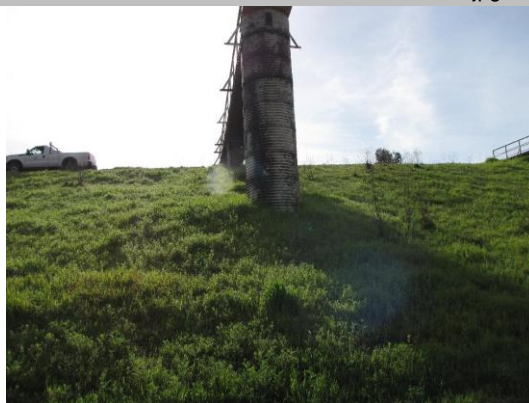
Photo 3 of 3 : UCIP\_SP\_2018\_42945\_69742.jpg

Comment Code					
Inspector Comment					
FS_ID:42945					
DS_ID:19090					
EP_NO: N/A					
Repair Type: No Action Needed					
Crossing Status: Found					
UCIP Comments:					
FIELD_STRUCT_DESC: 36-inch corrugated metal drainage pipe through levee, 27 feet below crown. Flap gate and concrete "U" headwall on waterside (WS) end. Slide gate in 48-inch corrugated metal riser on WS slope of pipe. Steel walkway to control gate. Outfall drains from Ellis Lake. Concrete headwall at both toes. Concrete base under riser units. Steel riser unit and slide gate added under Permit No. 4041, 1962-Marysville Levee Commission. [Additional Reference(s): DWR Levee Logs, 1993 and 2005. USACE Sacramento O&M Manual Unit No. 147, August 1955, (Station 8+48)]					
FS Date: 3/14/2013

View of waterward slope.

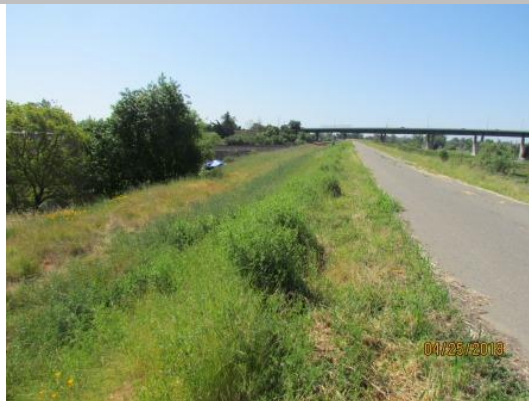
Photo 1 of 1 : SP\_2018\_NA0004\_105\_3\_20180427\_00013.jpg

LM Start	0.01	Rating **	M	Issue No.	3
LM End	1.24	Issue Type +	Ma	Location *	LS
Category	Earthen Levee			GPS Latitude/Longitude	
				Start	End
Item	Vegetation			39.149395 °	39.134464 °
				-121.601105 °	-121.594143 °
DWR ID	DWR_NA0004_02_s _ 2018_3				
Comment Code					
V1 : Control annual grass and weeds on the levee slopes and easements.					
Inspector Comment					
Annual vegetation needs to be maintained, Spring 2018.

View looking downstream landside of the annual vegetation that needs to be maintained, Spring 2018.

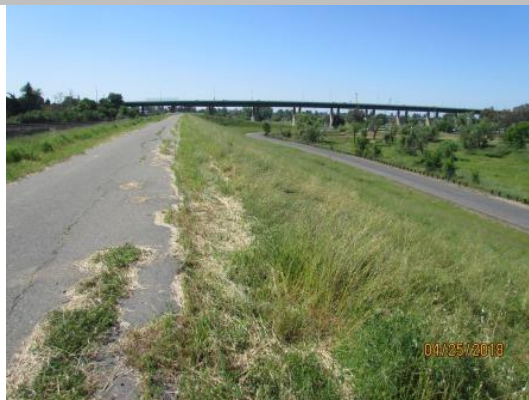
Photo 1 of 1 : SP\_2018\_NA0004\_105\_5\_20180427\_00012.jpg

LM Start	0.01	Rating **	M	Issue No.	5
LM End	1.24	Issue Type +	Ma	Location *	WS
Category	Earthen Levee			GPS Latitude/Longitude	
				Start	End
Item	Vegetation			39.149395 °	39.134464 °
				-121.601105 °	-121.594144 °
DWR ID	DWR_NA0004_02_s _ 2018_5				
Comment Code					
V1 : Control annual grass and weeds on the levee slopes and easements.					
Inspector Comment					
Annual vegetation needs to be maintained, Spring 2018.

View looking downstream waterside of the annual vegetation that needs to be maintained, Spring 2018.

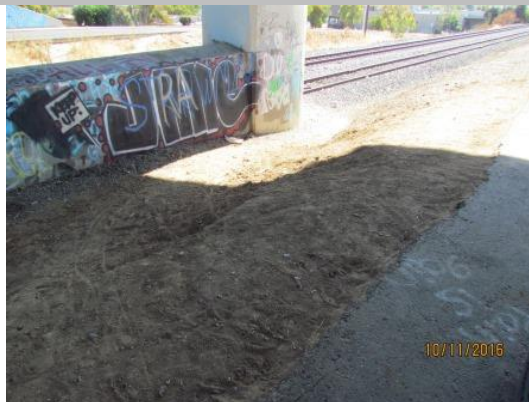
Photo 1 of 1 : SP\_2018\_NA0004\_105\_4\_20180302\_00001.jpg

LM Start	0.32	Rating **	A/W	Issue No.	4
LM End	0.32	Issue Type +	Ma	Location *	LS
Category	Earthen Levee			GPS Latitude/Longitude	
				Start	End
Item	Slope Stability			39.144840 °	39.144840 °
				-121.600559 °	-121.600559 °
DWR ID	DWR_NA0004_02_s_2016_4				
Comment Code					
S2 : Repair the levee slope damaged by foot traffic and prevent access where possible.					
Inspector Comment					
Foot path depression in the landside levee slope has been repaired, Spring 2017.

View looking downstream of landside slope erosion due to heavy foot traffic. Fall 2016. For Spring 2017 the foot path depression in the landside levee slope has been repaired.

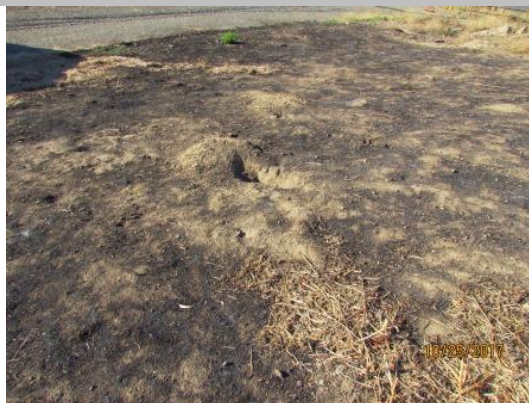
Photo 1 of 1 : SP\_2018\_NA0004\_105\_6\_20180302\_00002.jpg

LM Start	0.75	Rating **	M	Issue No.	6
LM End	0.75	Issue Type +	Ma	Location *	WS
Category	Earthen Levee			GPS Latitude/Longitude	
				Start	End
Item	Animal Control			39.138983 °	39.138983 °
				-121.600717 °	-121.600717 °
DWR ID	DWR_NA0004_02_f_2017_6				
Comment Code					
A1 : Exterminate rodents and backfill and compact or grout burrows.					
Inspector Comment					
Rodent holes need to be backfilled, Spring 2018.

View of landside of rodent holes, no animal activity was observed, Fall 2017.

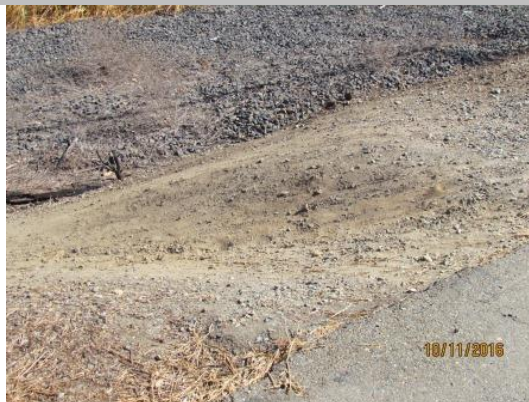
Photo 1 of 1 : SP\_2018\_NA0004\_105\_13\_20180302\_00004.jpg

LM Start	0.82	Rating **	M	Issue No.	13
LM End	0.82	Issue Type +	Ma	Location *	LS
Category	Earthen Levee			GPS Latitude/Longitude	
				Start	End
Item	Slope Stability			39.138827 °	39.138827 °
				-121.599530 °	-121.599530 °
DWR ID	DWR_NA0004_02_f_2016_13				
Comment Code					
S2 : Repair the levee slope damaged by foot traffic and prevent access where possible.					
Inspector Comment					
Foot path depression in the landside levee slope needs to be repaired.

View of foot path depression in the landside levee slope.

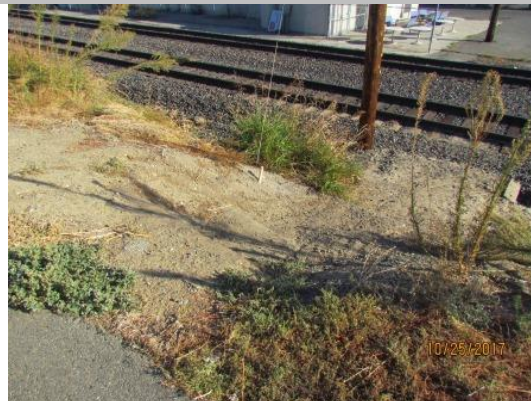
Photo 1 of 1 : SP\_2018\_NA0004\_105\_14\_20180302\_00005.jpg

LM Start	0.85	Rating **	M	Issue No.	14
LM End	0.85	Issue Type +	Ma	Location *	LS
Category	Earthen Levee			GPS Latitude/Longitude	
				Start	End
Item	Slope Stability			39.138463 °	39.138463 °
				-121.599168 °	-121.599168 °
DWR ID	DWR_NA0004_02_f_2016_14				
Comment Code					
S2 : Repair the levee slope damaged by foot traffic and prevent access where possible.					
Inspector Comment					
Remove steps that are cut into levee slope, Fall 2017.

View of steps for foot path in the landside levee slope, Fall 2017.

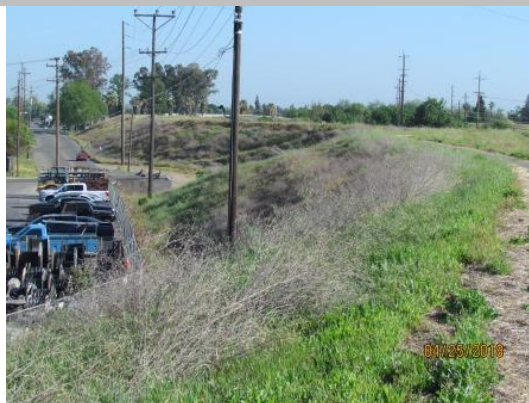
Photo 1 of 1 : SP\_2018\_NA0004\_106\_17\_20180427\_00046.jpg

LM Start	0.12	Rating **	U	Issue No.	17
LM End	4.81	Issue Type +	Ma	Location *	LS
Category	Earthen Levee			GPS Latitude/Longitude	
				Start	End
Item	Vegetation			39.135167 °	39.185036 °
				-121.591631 °	-121.540321 °
DWR ID	DWR_NA0004_03_s_2018_17				
Comment Code					
V1 : Control annual grass and weeds on the levee slopes and easements.					
Inspector Comment					
Annual vegetation needs to be maintained, Spring 2018.

View looking downstream waterside of the annual vegetation that needs to be maintained, Spring 2018.

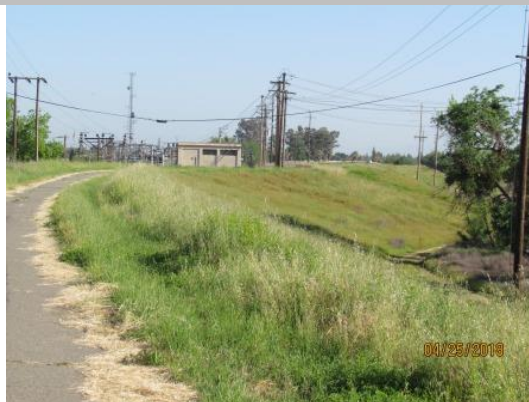
Photo 1 of 1 : SP\_2018\_NA0004\_106\_19\_20180427\_00047.jpg

LM Start	0.12	Rating **	U	Issue No.	19
LM End	4.81	Issue Type +	Ma	Location *	WS
Category	Earthen Levee			GPS Latitude/Longitude	
				Start	End
Item	Vegetation			39.135167 °	39.185036 °
				-121.591631 °	-121.540321 °
DWR ID	DWR_NA0004_03_s_2018_19				
Comment Code					
V1 : Control annual grass and weeds on the levee slopes and easements.					
Inspector Comment					
Annual vegetation needs to be maintained, Spring 2018.

View looking upstream waterside of the annual vegetation that needs to be maintained, Spring 2018.

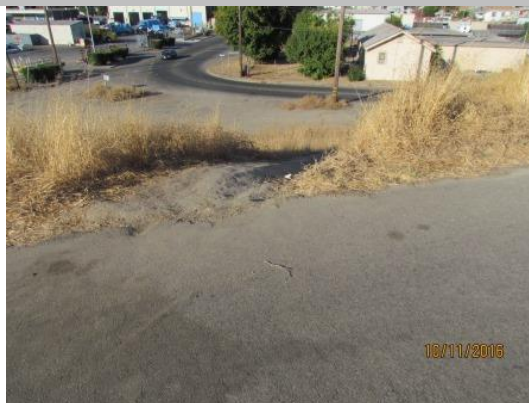
Photo 1 of 1 : SP\_2018\_NA0004\_106\_30\_20180302\_00009.jpg

LM Start	1.00	Rating **	M	Issue No.	30
LM End	1.00	Issue Type +	Ma	Location *	LS
Category	Earthen Levee			GPS Latitude/Longitude	
				Start	End
Item	Erosion / Bank Caving			39.142167 °	39.142167 °
				-121.582817 °	-121.582817 °
DWR ID	DWR_NA0004_03_f_2016_30				
Comment Code					
E1 : Note and monitor erosion site.					
Inspector Comment					
Path cut in by foot traffic on the landside slope needs to be repaired.

View of path cut in by foot traffic on the landside slope.

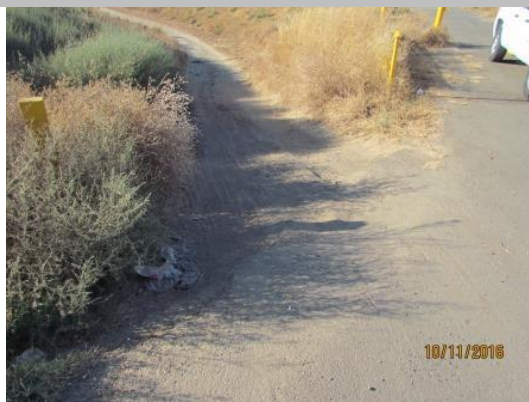
Photo 1 of 1 : SP\_2018\_NA0004\_106\_32\_20180302\_00010.jpg

LM Start	1.16	Rating **	M	Issue No.	32
LM End	1.16	Issue Type +	Ma	Location *	WS
Category	Earthen Levee			GPS Latitude/Longitude	
				Start	End
Item	Slope Stability			39.144392 °	39.144392 °
				-121.582930 °	-121.582930 °
DWR ID	DWR_NA0004_03_f_2016_32				
Comment Code					
S3 : Repair the levee slope damaged by vehicle traffic and prevent access where possible.					
Inspector Comment					
Ruts cut in by vehicle traffic on the landside slope needs to be repaired, Fall 2017.

View of ruts cut in by vehicle traffic on the waterside slope.

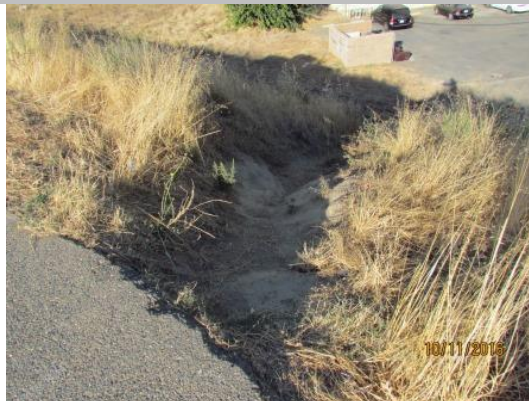
Photo 1 of 1 : SP\_2018\_NA0004\_106\_33\_20180302\_00011.jpg

LM Start	1.28	Rating **	M	Issue No.	33
LM End	1.28	Issue Type +	Ma	Location *	LS
Category	Earthen Levee			GPS Latitude/Longitude	
				Start	End
Item	Slope Stability			39.145723 °	39.145723 °
				-121.581323 °	-121.581323 °
DWR ID	DWR_NA0004_03_f_2016_33				
Comment Code					
S2 : Repair the levee slope damaged by foot traffic and prevent access where possible.					
Inspector Comment					
Path cut in by foot traffic on the landside slope needs to be repaired, Fall 2017.

View of path cut in by foot traffic on the landside slope that needs repaired.

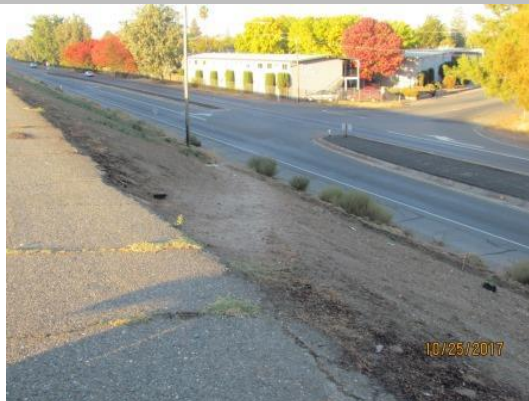
Photo 1 of 1 : SP\_2018\_NA0004\_106\_40\_20180302\_00016.jpg

LM Start	2.21	Rating **	M	Issue No.	40
LM End	2.21	Issue Type +	Ma	Location *	LS
Category	Earthen Levee			GPS Latitude/Longitude	
				Start	End
Item	Slope Stability			39.155076 °	39.155076 °
				-121.568970 °	-121.568970 °
DWR ID	DWR_NA0004_03_f_2016_40				
Comment Code					
S2 : Repair the levee slope damaged by foot traffic and prevent access where possible.					
Inspector Comment					
Erosion from foot traffic should be repaired, Spring 2018.

View looking downstream landside of foot path that is cut into the landside levee slope, Fall 2017.

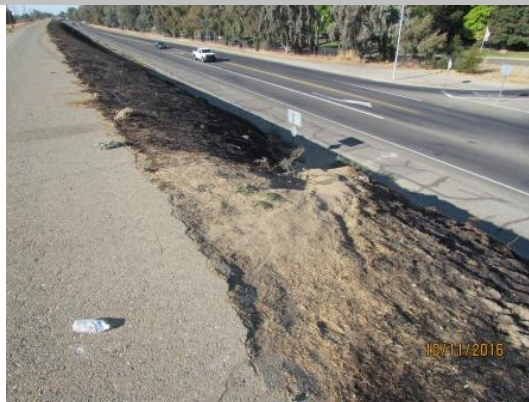
Photo 1 of 1 : SP\_2018\_NA0004\_106\_41\_20180302\_00017.jpg

LM Start	2.55	Rating **	M	Issue No.	41
LM End	2.55	Issue Type +	Ma	Location *	LS
Category	Earthen Levee			GPS Latitude/Longitude	
				Start	End
Item	Slope Stability			39.158509 °	39.158509 °
				-121.564423 °	-121.564423 °
DWR ID	DWR_NA0004_03_f_2016_41				
Comment Code					
S2 : Repair the levee slope damaged by foot traffic and prevent access where possible.					
Inspector Comment					
Erosion from foot traffic should be repaired, Spring 2018.

View looking downstream of foot path that has cut into the landside slope.
